Conflagration to Code: How Historic Building Fires Shaped Modern Codes

Thomas W. Gardner, PE, FSFPE, LEED AP
October 2018

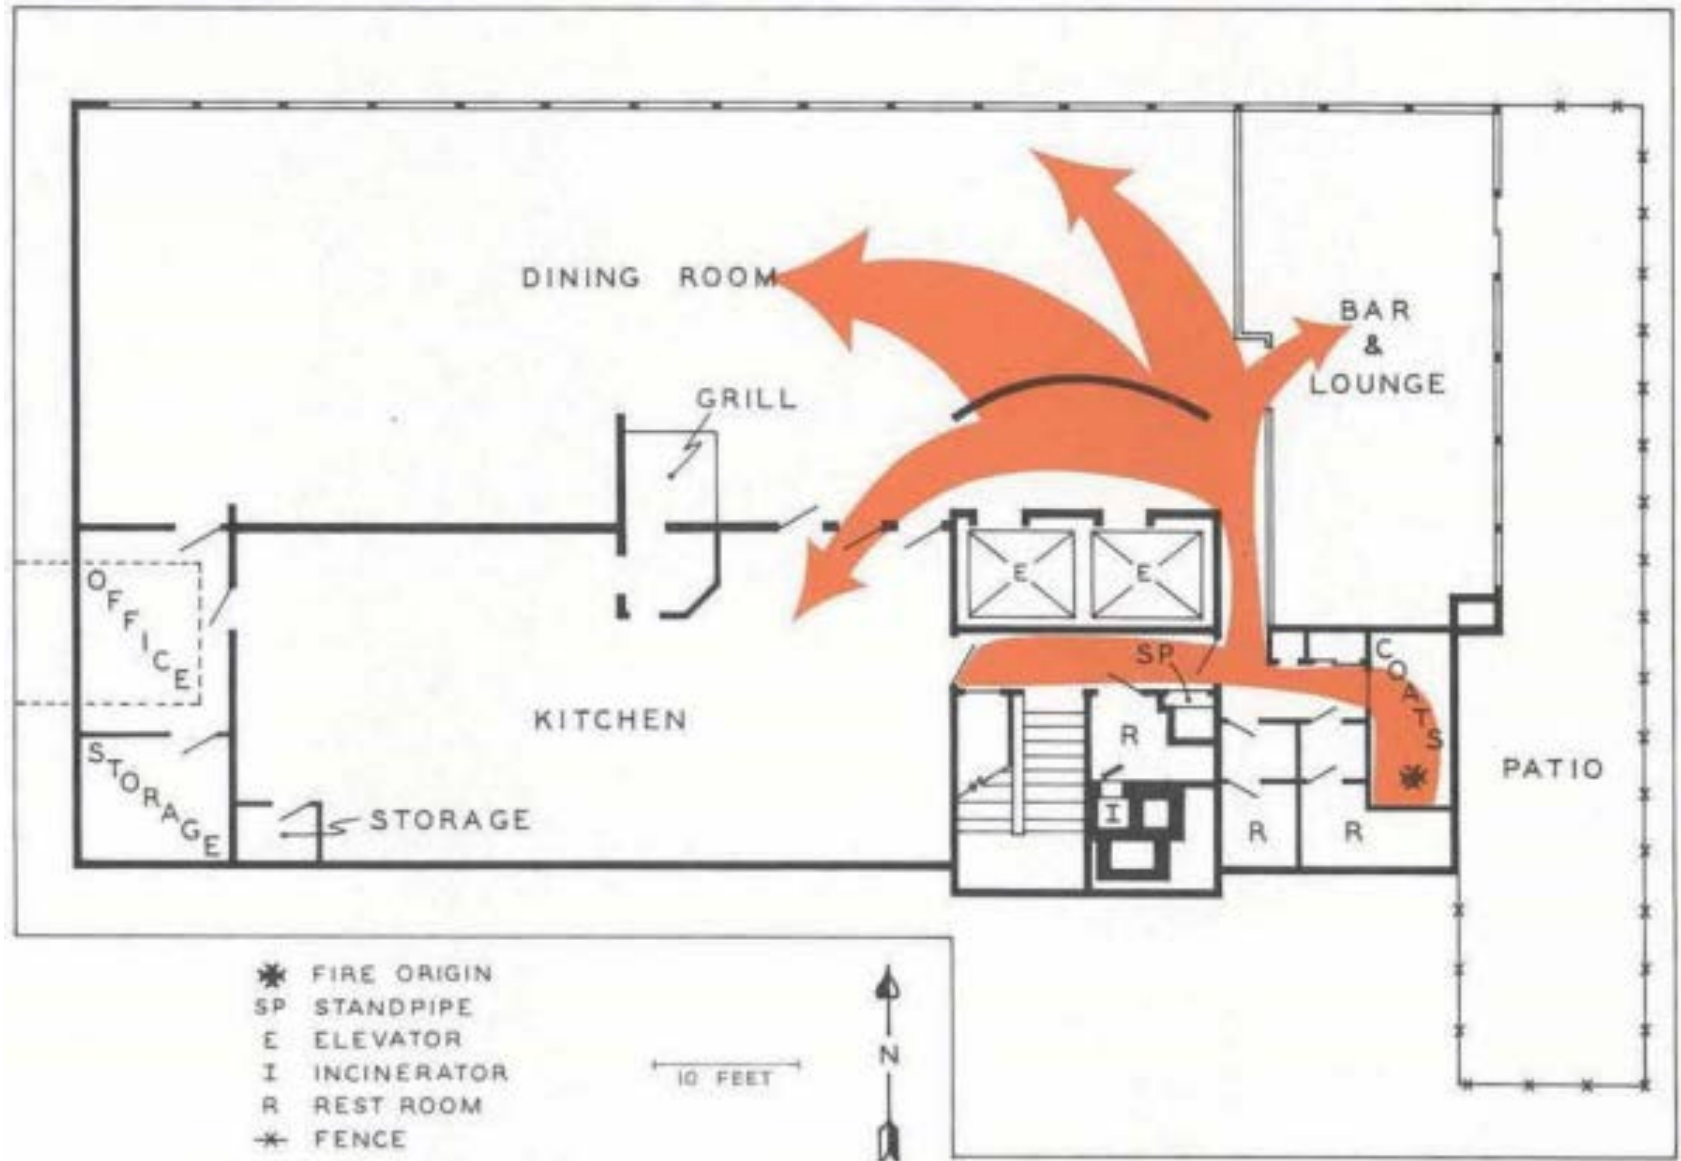
Penthouse layout (4,700 square feet)

- Fire discovered in unattended coat room
- Customer discovered fire; reported it to manager
- Manager found chef already attempted to use a portable extinguisher and then attempts to warn apartment occupants
- Chef takes 2 car loads of people down by elevator
- No one warned customers
- Fire reaches combustible ceiling – extends into dining room, cutting off access to stair from the coat-room side.
- Hostess leads customers thru kitchen, but finds stair access impassable.
- Most bodies are found in the kitchen above location of the 2nd stair below.

- Renovation expanded penthouse but did not extend 2nd stair to penthouse level
- Non sprinklered assembly occupancy
- Combustible ceiling tile, paneling and decorations
- Delay in calling fire department
- Elevators failed

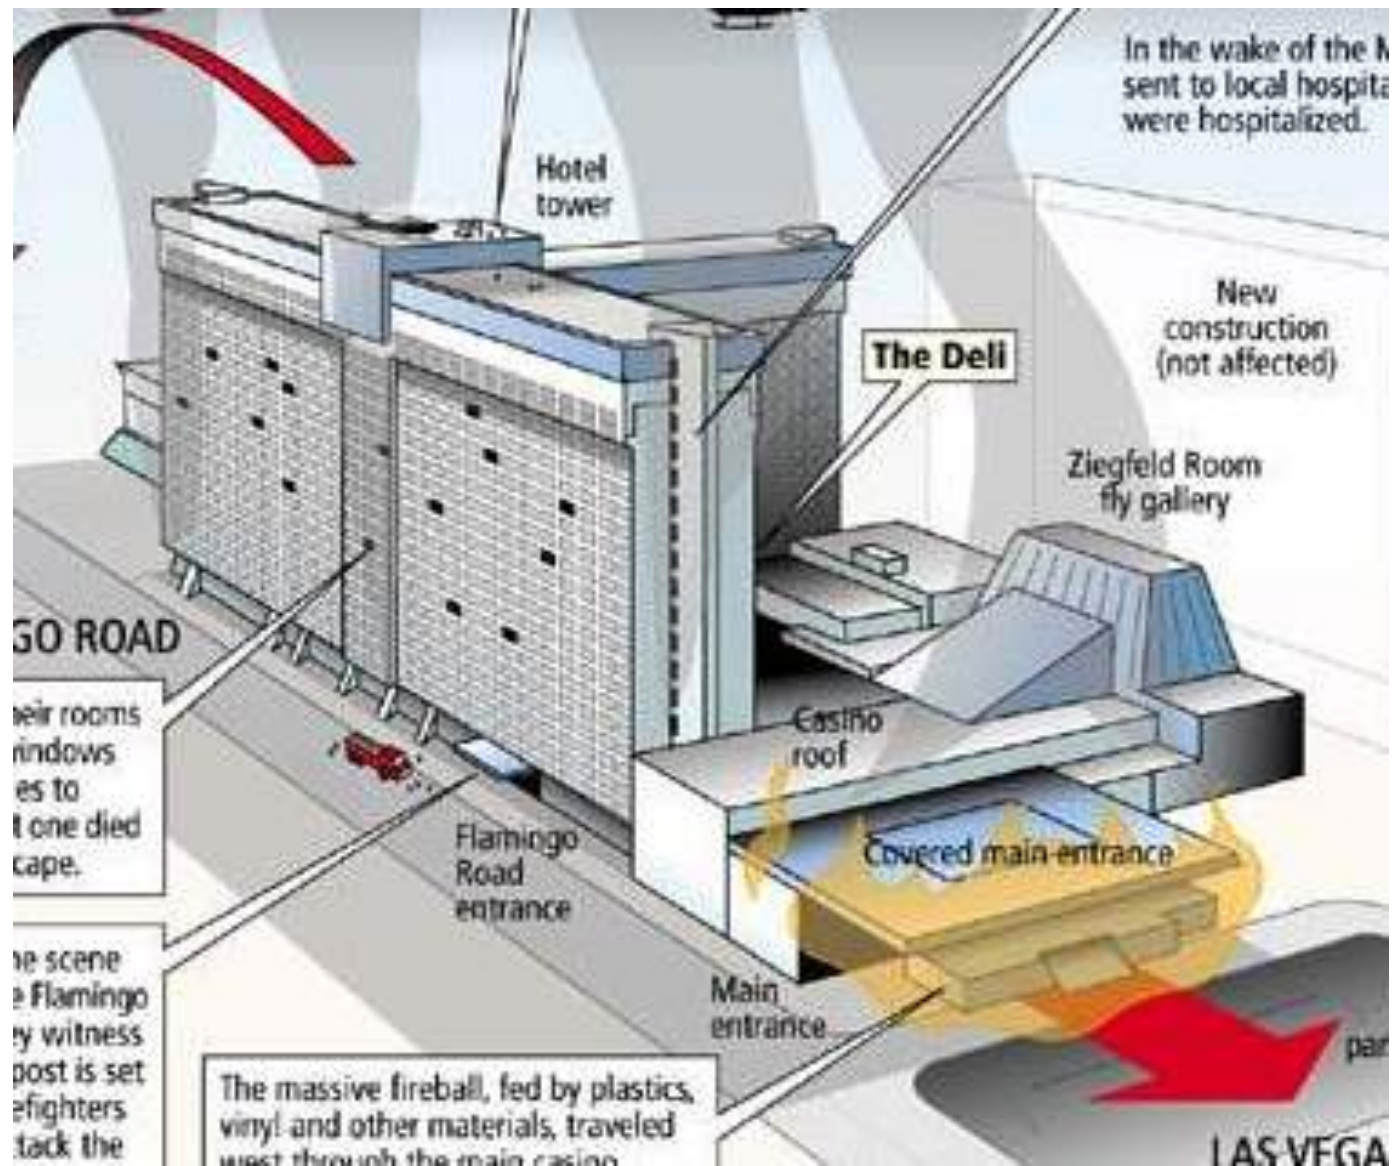
Hotel complex layout

- Las Vegas, NV
- Hotel/Casino complex
- 5,000 people
- 26-story high rise
- 6 stairwells
- Partially sprinklered
- Manual fire alarm system
- 85 Dead

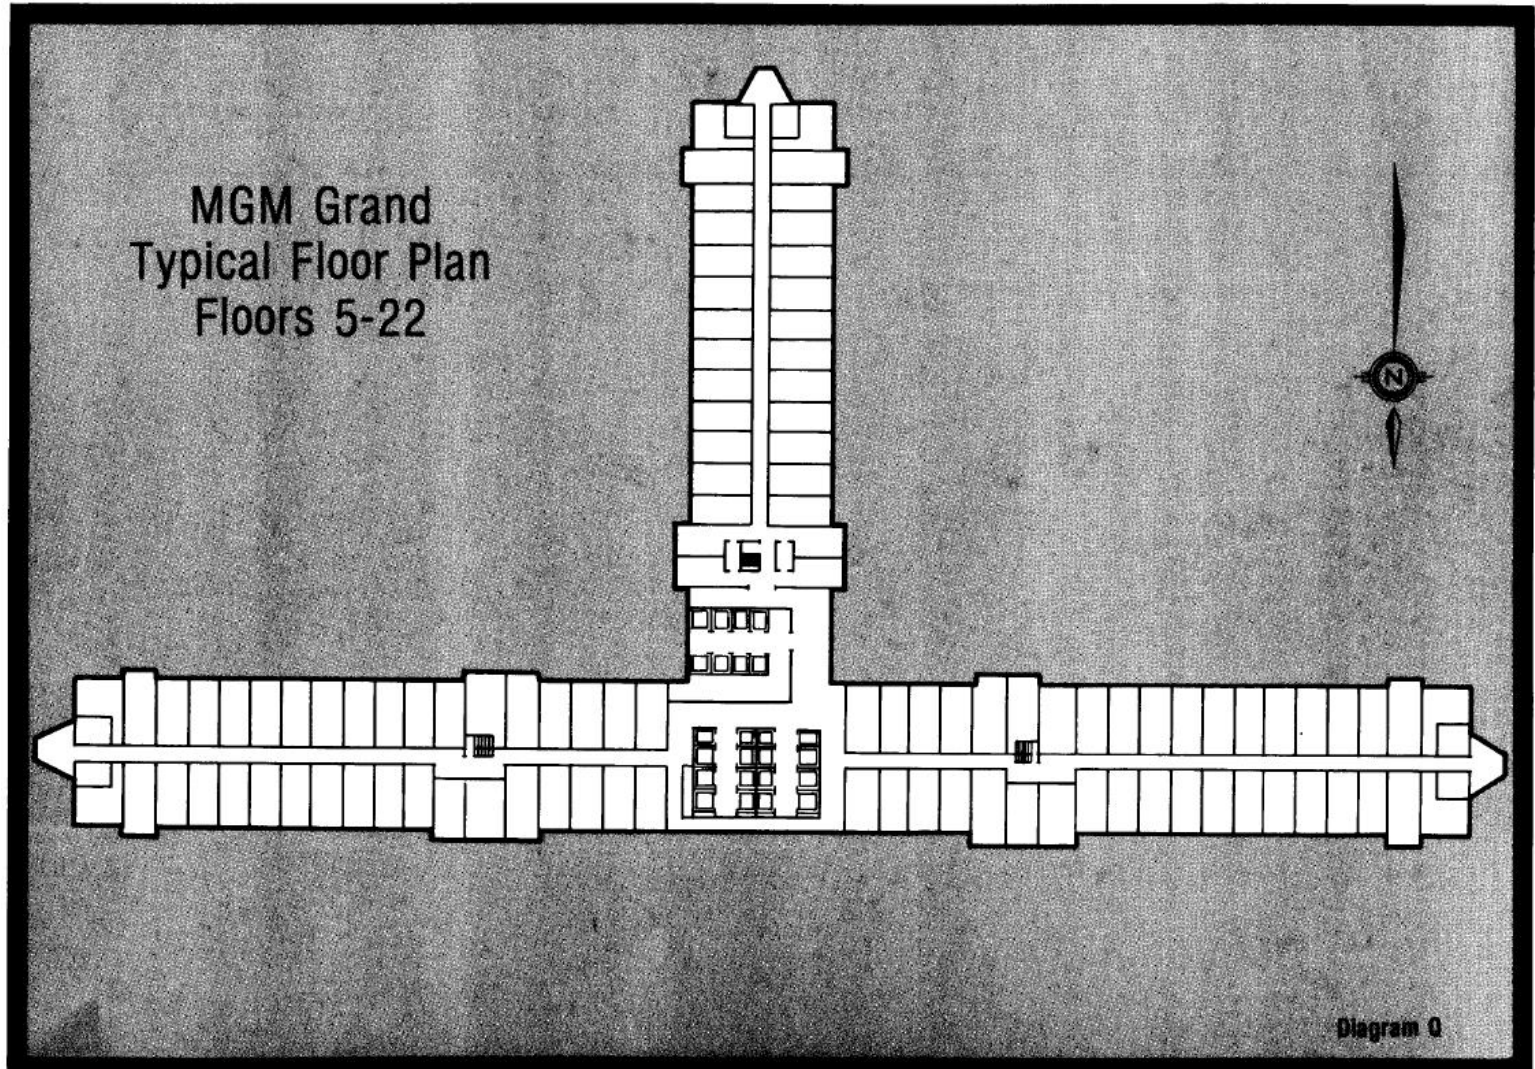
Hotel floor plan

- Electrical fire discovered in deli
- Security and employees attempt to fight the fire
- Fire spreads to the casino
- Casino is fully involved within 6 minutes of fire discovery
- Seismic joints, elevator shafts and common plenum spread smoke through the hotel

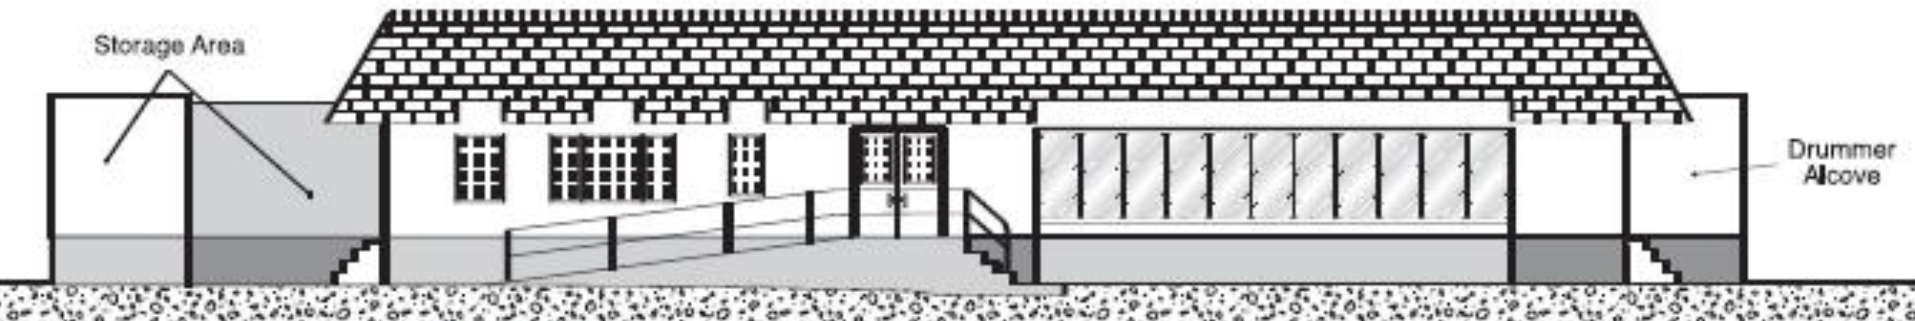
FIGURE 5 Front (north) View of The Station Nightclub.
